Battery Reinitialization of the Photovoltaic Module of the International Space Station

Gyan Hajela and Fred Cohen
The Boeing Company, Canoga Park, California

Prepared for the
37th Intersociety Energy Conversion Engineering Conference
sponsored by the Institute of Electrical and Electronics Engineers,
Electron Devices Society
Washington, DC, July 28–August 2, 2002

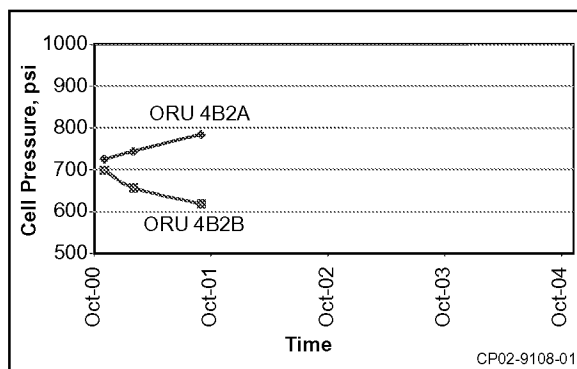
FIGURE 1. BATTERY 4B2 ORU PRESSURES

the battery 4B2. Battery 4B2 is showing a larger than expected pressure difference and the pressure difference is rising with time, Figure 1. However, the remaining parameters of this battery remain well within the ranges specified above—intercell temperature gradient $\sim 1.5^{\circ}\text{C}$, intercell voltage gradient $\sim 0.03\text{ V}$, ORU voltage difference $\sim 0.5\text{ V}$.

The 4B2 Battery is comprised of two ORUs that have cycle history differences or ages. This age difference was caused by 2 years of on-ground IEA testing. When the power channels were populated, the battery ORUs were matched to another containing cells of the same vintage (activation dates) but battery 4B2 contains two ORUs that have different ground test histories. We continue to monitor this battery very closely.

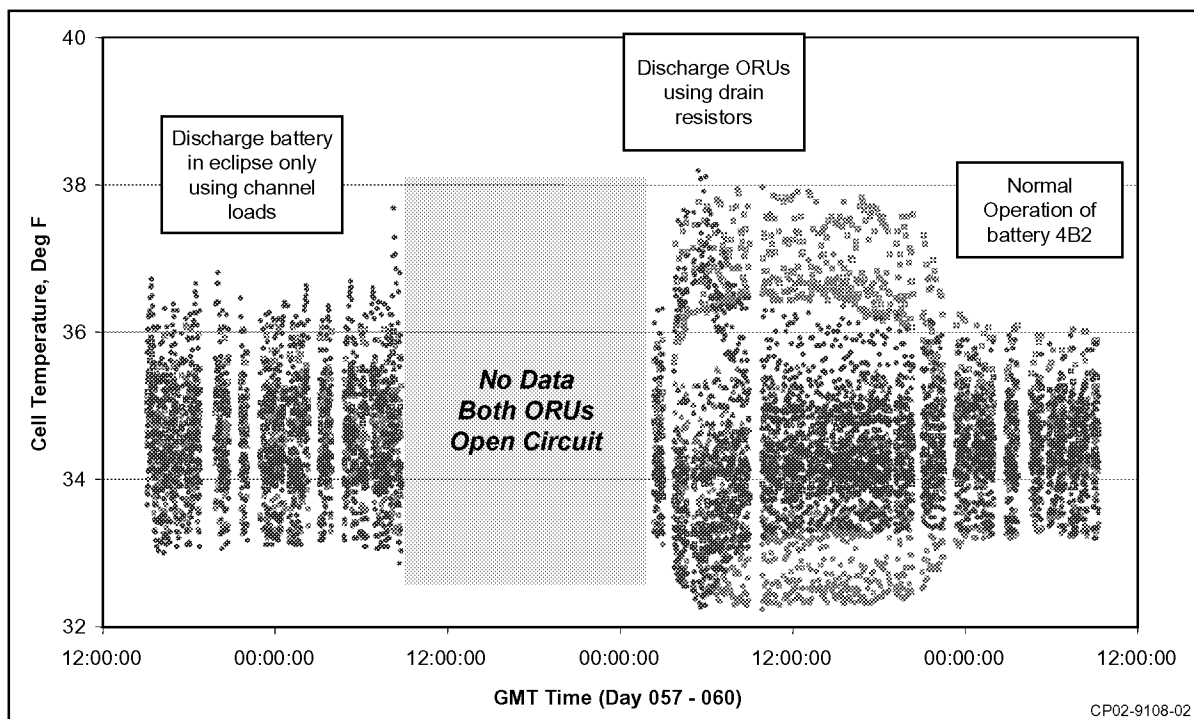
FIGURE 2. MONITORED BATTERY CELL TEMPERATURES

- Figure 2 shows the battery cell temperature during this step. All cells remain well within the allowable temperature limits of 32 to 50°F, and the temperature difference between cells remained within a design-to range of 5.4°F.

- Figure 2 shows that all cells remained well within the allowable temperature limits of 32 to 50°F. Note that the temperature difference between cells remained within a design-to range of 5.4°F.

- Figure 2 shows that all cells remained well within the allowable temperature ranges.
 - Figure 3 shows that it was cell #04 of ORU 4B2A that dropped first. Due to loss of communications with the ISS, the data showing drop to 0.1 V were lost.

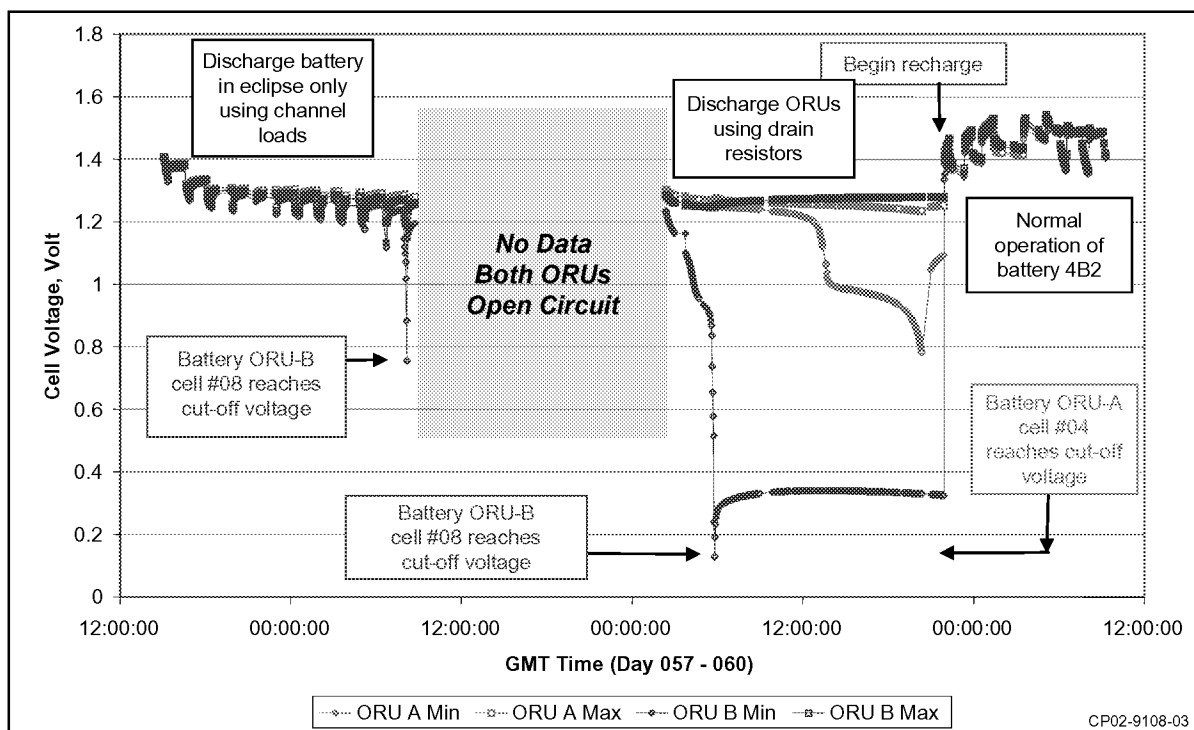
FIGURE 3. BATTERY CELL VOLTAGES, MIN AND MAX

- Figure 3 shows cell voltages. It shows that the cell #08 of ORU 4B2B reached the cutoff voltage first.
 - Figure 4 shows ORU voltages and the battery voltage (sum of the voltages of the two ORUs connected in series). It shows that the battery voltage remained well above the cutoff value of 76 V.

- Figure 3 shows that it was again the cell #08, of ORU 4B2B, which reached the cutoff voltage of 0.1 V first.
 - Note that cells in the ORU 4B2A has still not reached the first cutoff level, cell voltage below 0.7 V. This clearly shows the inequality of stored capacity between the two ORUs.

- Also note that the ORU 4B2B, cell #08 voltage rose to about 1.2 V when it was disconnected from the load (after dropping to below 0.7 V). Similar trend was demonstrated after this cell reached the second cutoff voltage of 0.1 V while on the drain resistor. The voltage rose again, to about 0.3 V, as soon as the drain resistor was disengaged.

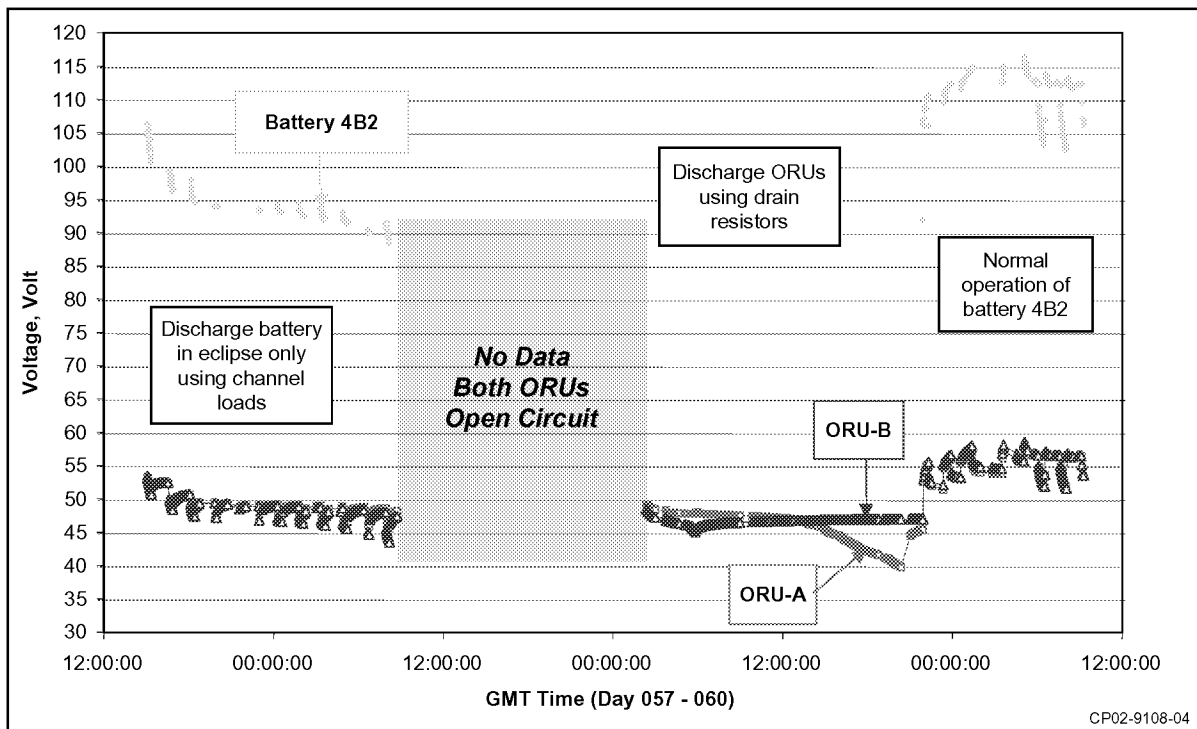
FIGURE 4. 4B2 VOLTAGES VS. TIME

- Figure 4 shows that the battery voltage remained well above the cutoff value of 76 V.
 - Figure 5 shows that cells of ORU 4B2A and 4B2B remained tightly grouped together, as before. Average pressure of ORU 4B2A and 4B2B remained apart by about the same value during this step, that is, no change in the ORU pressure differential.

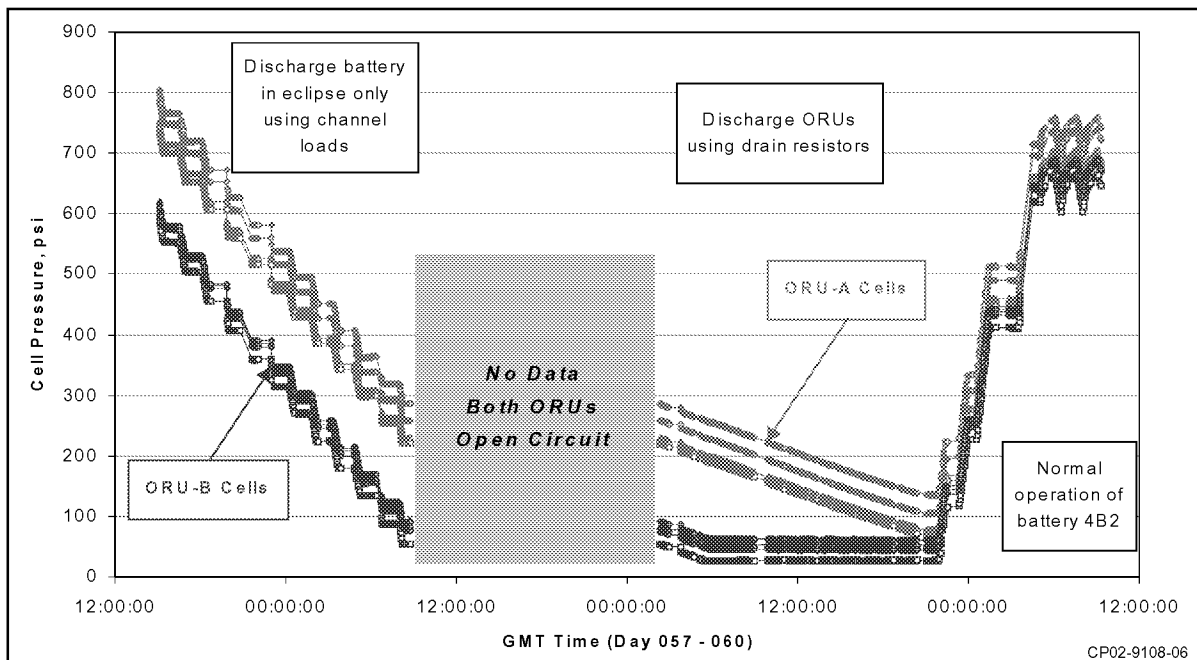
FIGURE 5. MONITORED CELL PRESSURES

- Figure 5 shows cell pressures. It can be seen that cells of ORU 4B2A and 4B2B remained tightly grouped together. Cell pressures dropped steadily during the eclipse periods and stayed unchanged during the insolation periods (charge inhibited). Average pressure of ORU 4B2A and 4B2B remained apart by about the same value during the discharge.

- Figure 5 shows that cells of ORU 4B2A and 4B2B remained tightly grouped together, as before. Pressure of cells in ORU 4B2A dropped during this step while pressure of cells in ORU 4B2B stayed the same. ORU pressure differential, at the time when ORU 4B2A reached the cell cutoff voltage, was reduced to 50 psi.

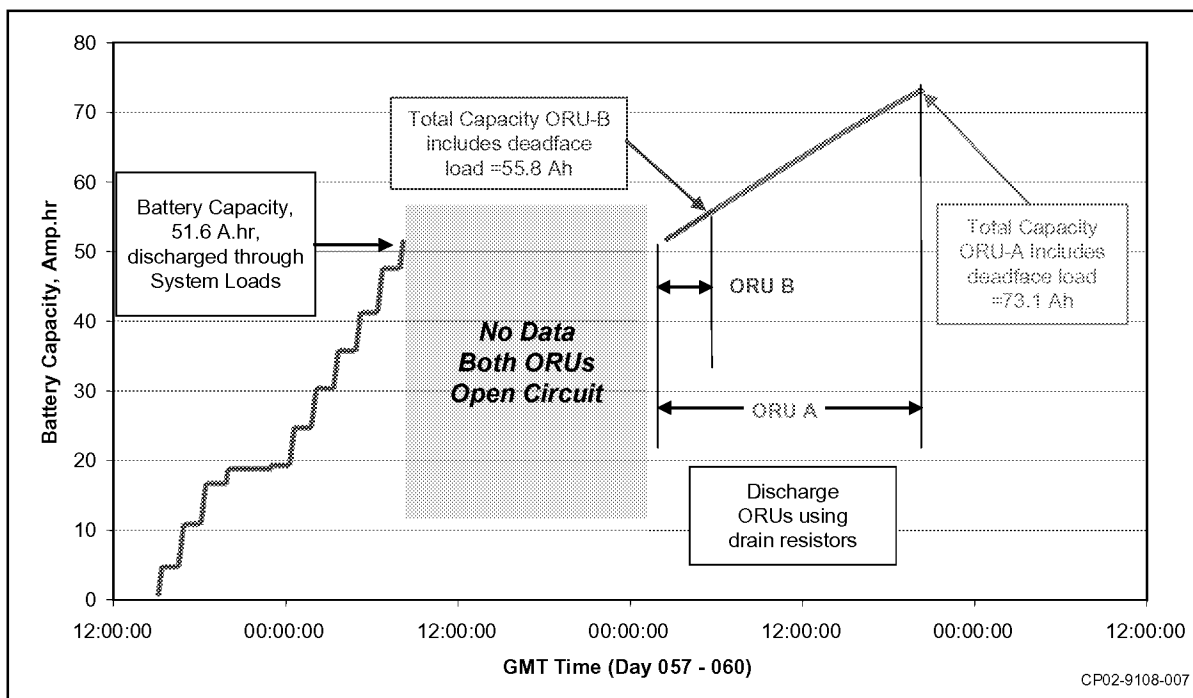
FIGURE 6. CALCULATED CAPACITY

- Figure 6 shows the battery capacity. It shows that the battery capacity was 51.6 A.hr at this rate of discharge (~17 A.). Note that the batteries need to discharge 50 A.hr to satisfy all discharge power requirements (continuous and contingency) and, thus, it is shown that the batteries continued to meet or exceed all power performance requirements even before reinitialization.
